Vibration Testing and Troubleshooting of Coke Drums

Mahmod Samman, Ph.D., P.E.

Stress Engineering Services, Inc.

Coking.com Calgary Conference
September 2009

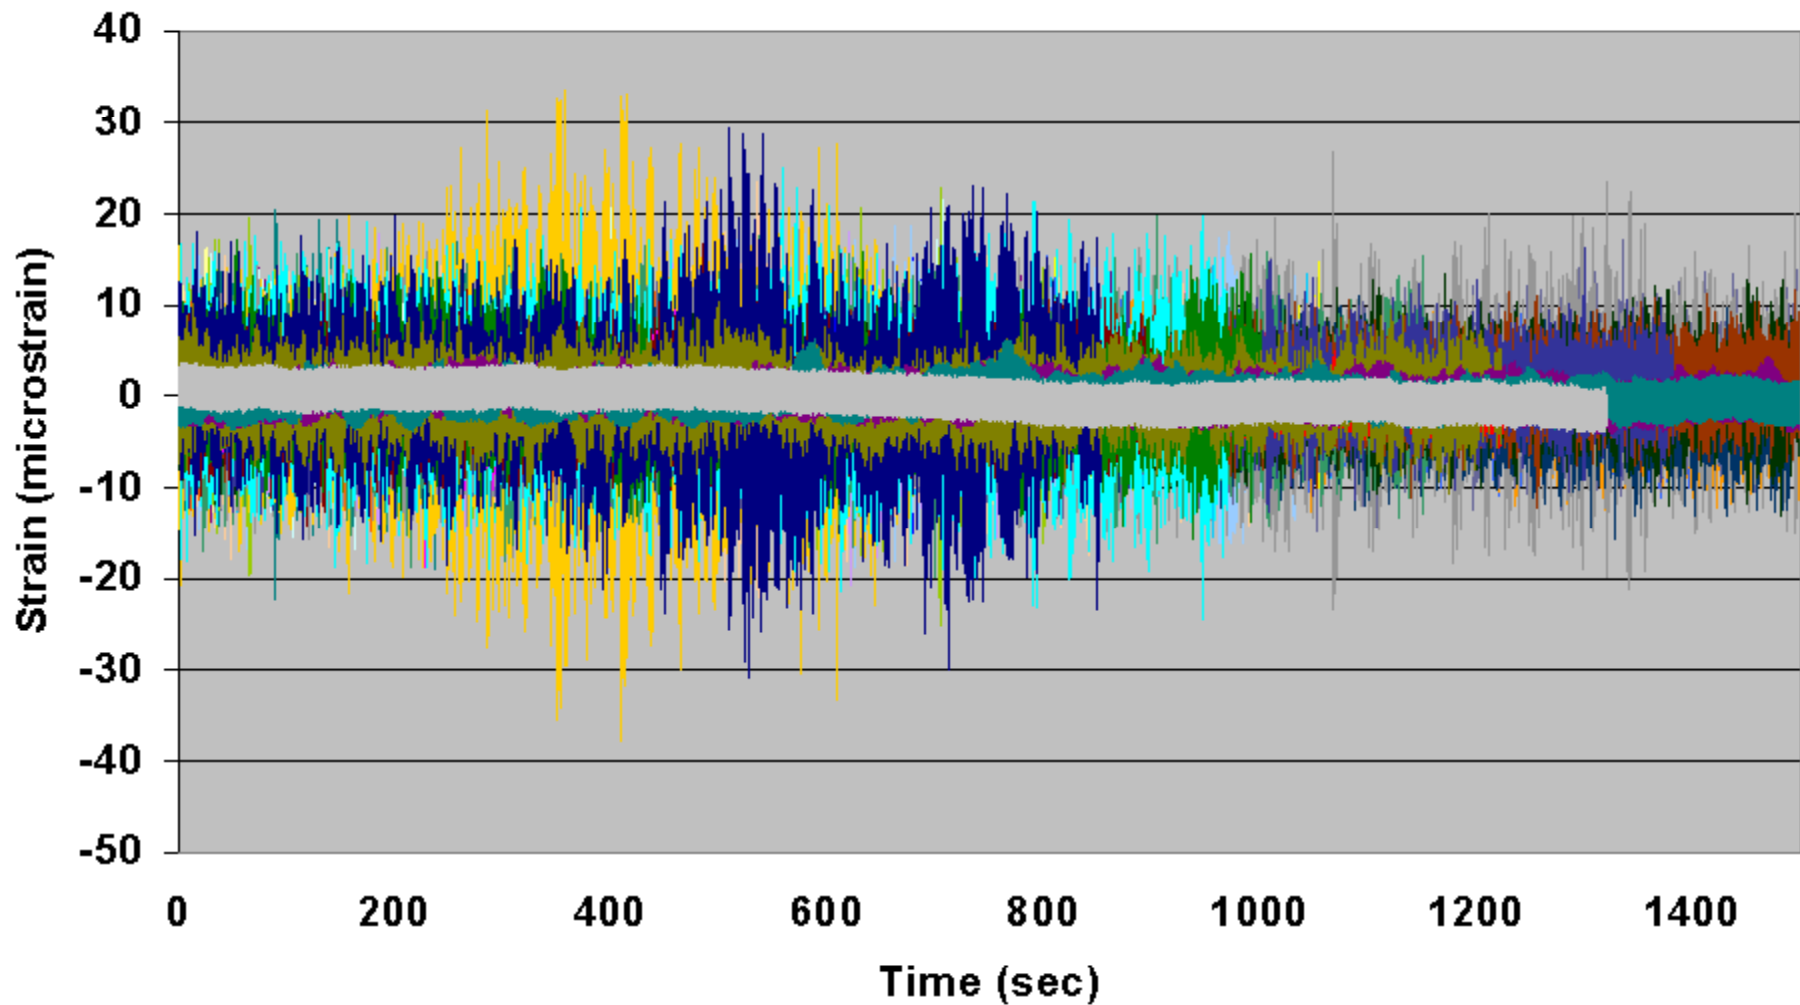
Strain Gauge Data

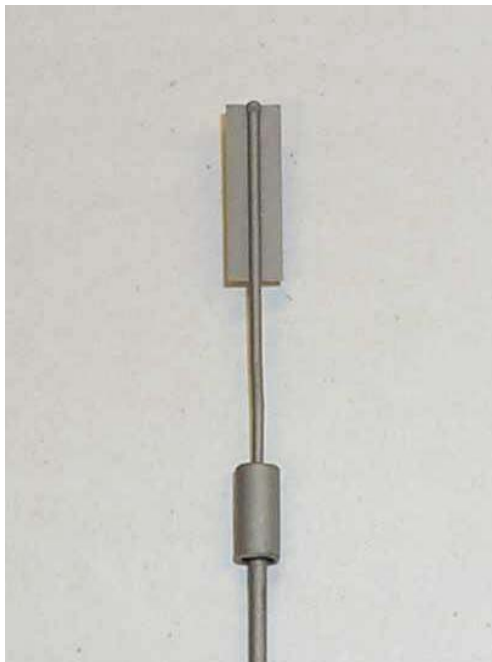
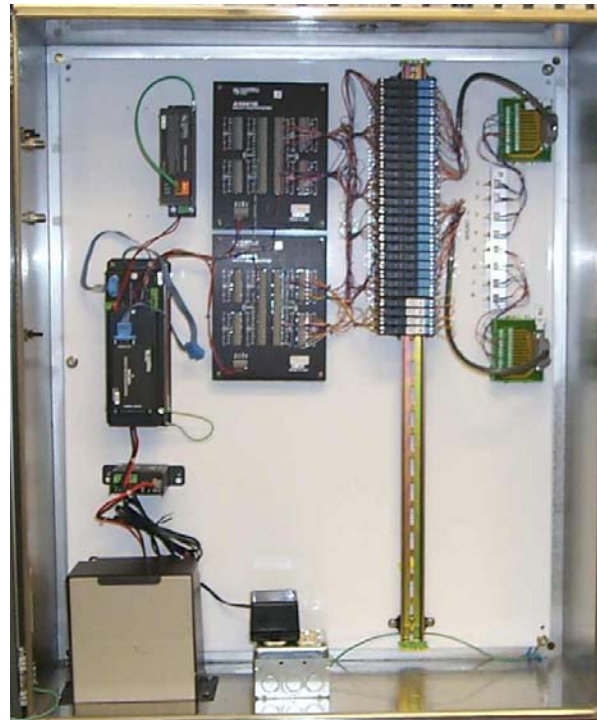
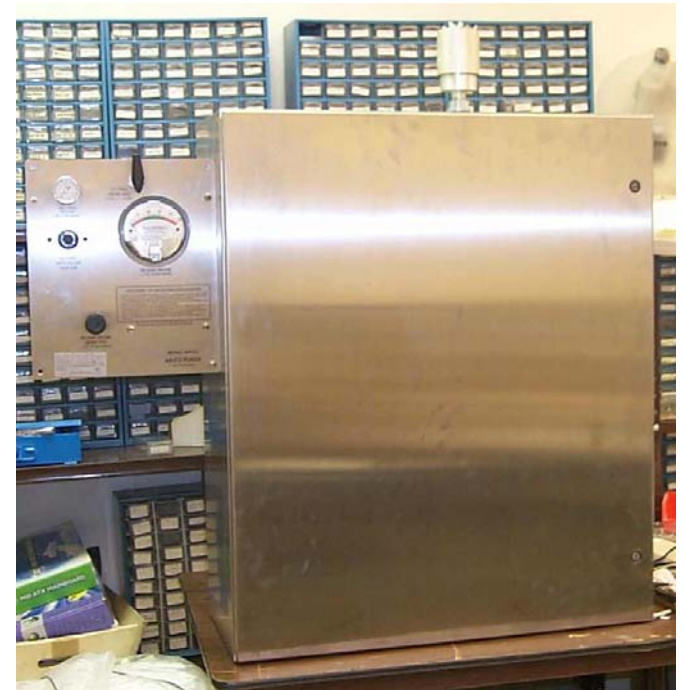
Intrinsically Safe Instrumentation System

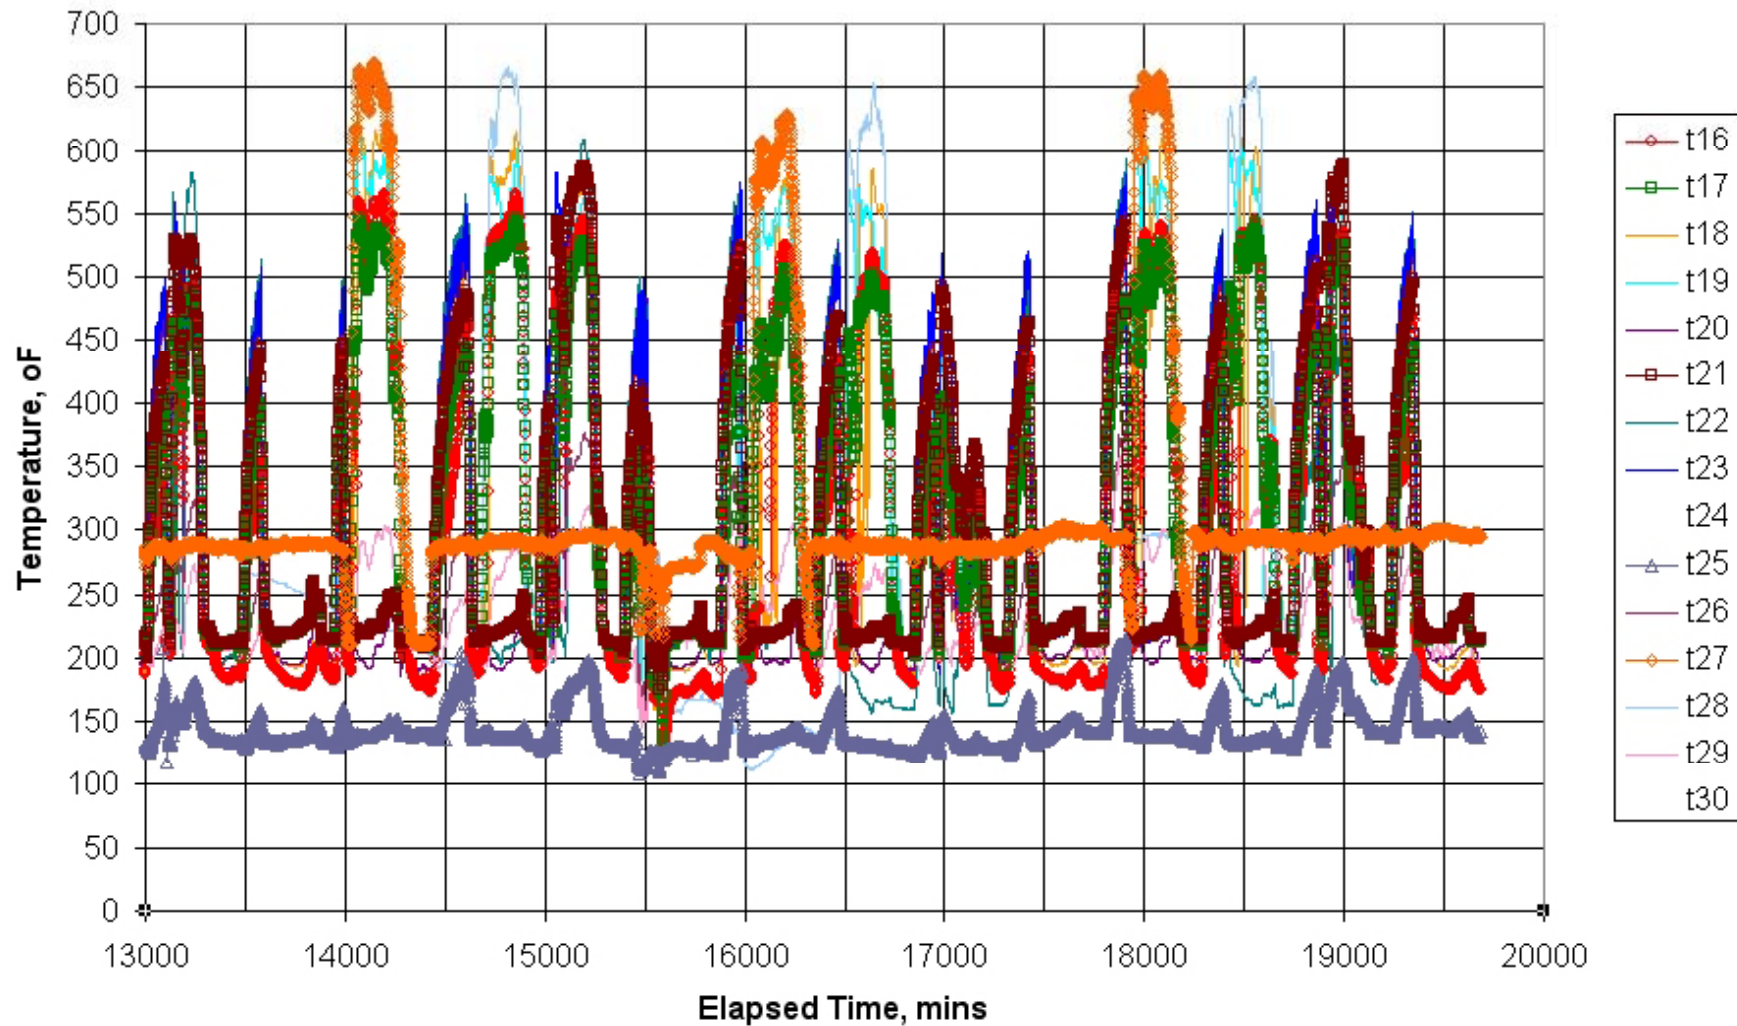
TEMPERATURE MEASUREMENTS

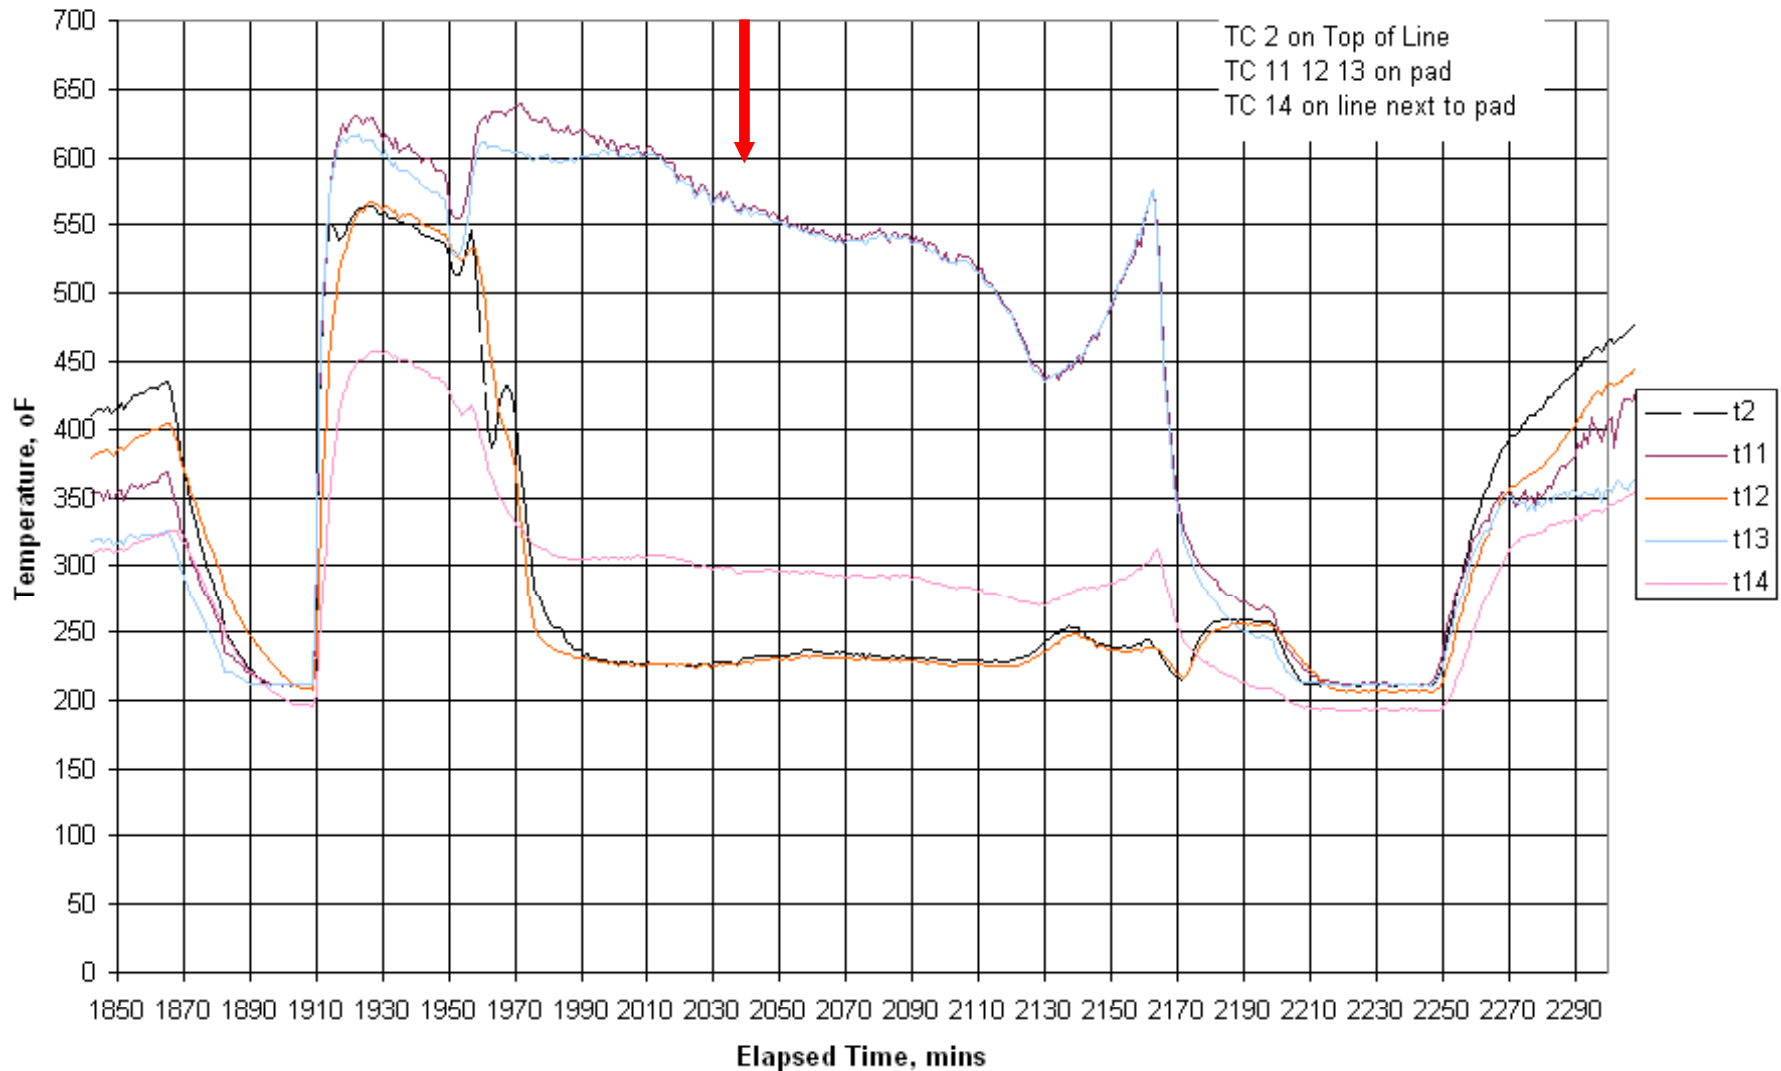
PAD THERMAL GRADIENTS

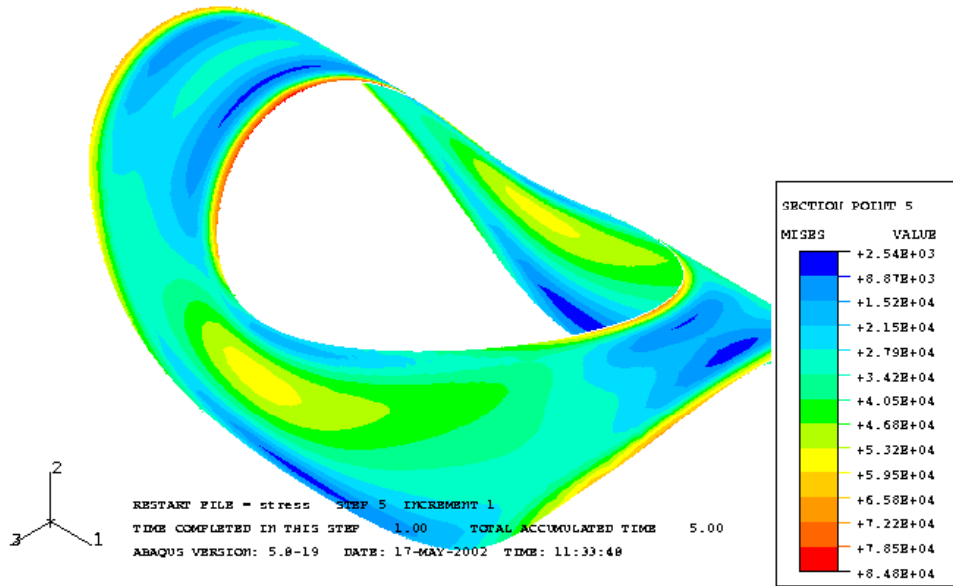
Von Mises Stress inside the pad

outside

inside
